# Incomplete cusp fractures: Early diagnosis and communication with patients using fiber-optic transillumination and intraoral photography

Samer S. Alassaad, DDS

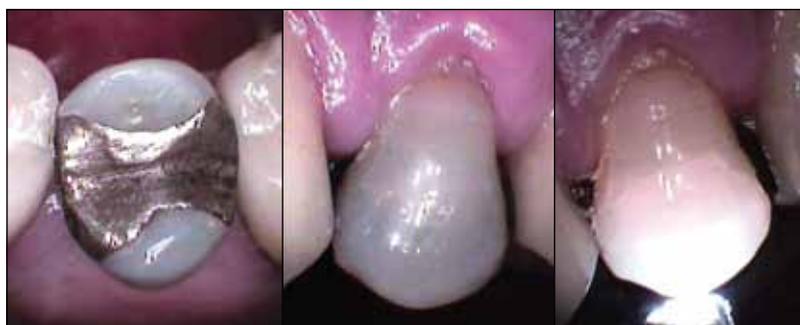
Fig. 1. Maxillary second premolar. *Left:* Occlusal view of cusps weakened by an intracoronal metallic restoration. *Center:* Buccal view. *Right:* Buccal view of a transilluminated buccal cusp showing an incomplete fracture.

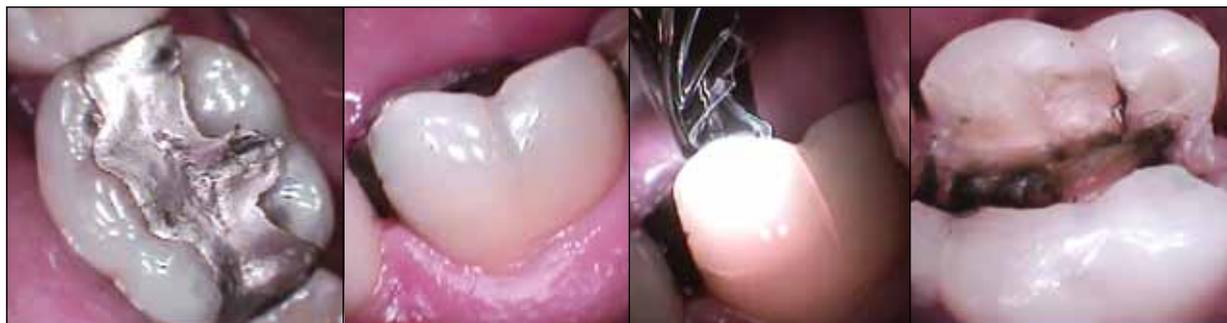
Fig. 2. Mandibular first molar. *Far left:* Occlusal view. *Center left:* Lingual view. *Center right:* Lingual view of a transilluminated mesiolingual cusp. An oblique fracture warrants further investigation. *Far right:* Oblique fracture involving both mesiolingual and distolingual cusps viewed under the light source of the intraoral camera.

Once an incomplete cusp fracture is identified, removing the existing restoration together with its liner and any present caries is recommended to directly visualize the extension of the fracture.<sup>1,8</sup> Oblique fractures usually will be visible at internal line angles of the preparation. Some of these fractures can appear lighter than the rest of the tooth structure due to refraction of the illuminating light of the operator or the intraoral camera along the fracture line (Fig. 2). Old fractures under metallic restorations may be accentuated due to the presence of stains

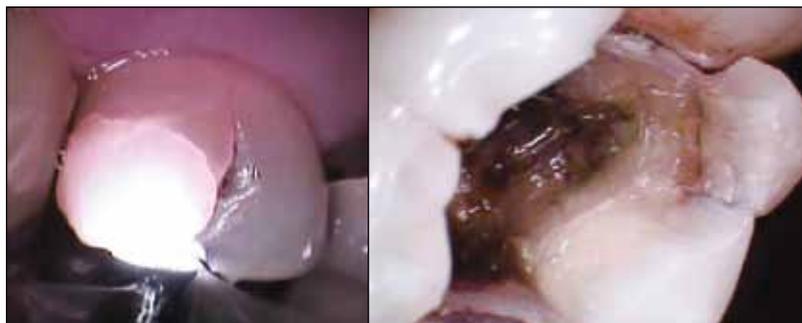
Fig. 3. Maxillary second molar. *Left:* Lingual view of a transilluminated distolingual cusp. *Right:* Intracoronal surface of a distolingual cusp. An old fracture is accentuated by the presence of a stain.

(Fig. 3). However, the extension of some other fractures may be determined only by fiber-optic light transillumination (Fig. 4).

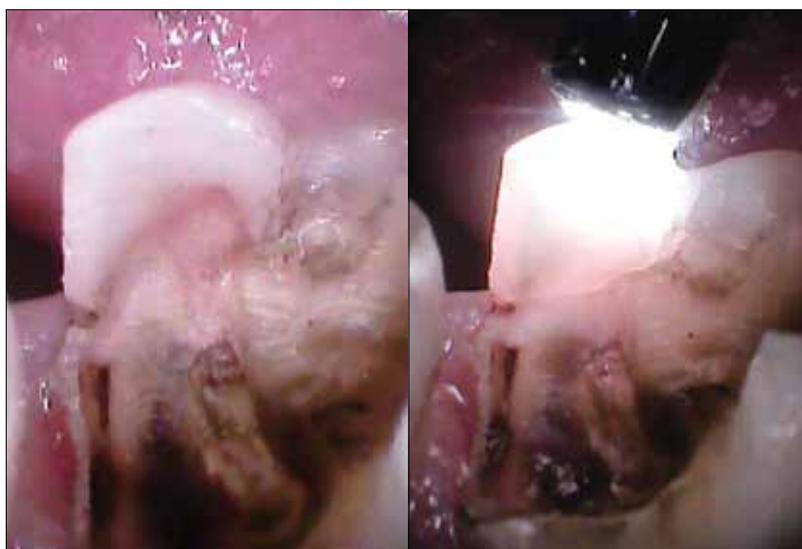
Fig. 4. Intracoronal surface of a mesiolingual cusp on a mandibular first molar. *Left:* The oblique fracture is not completely visible under the light source of the intraoral camera. *Right:* The extension of the oblique fracture is more visible with fiber-optic transillumination.
